This is what water can do over the years!

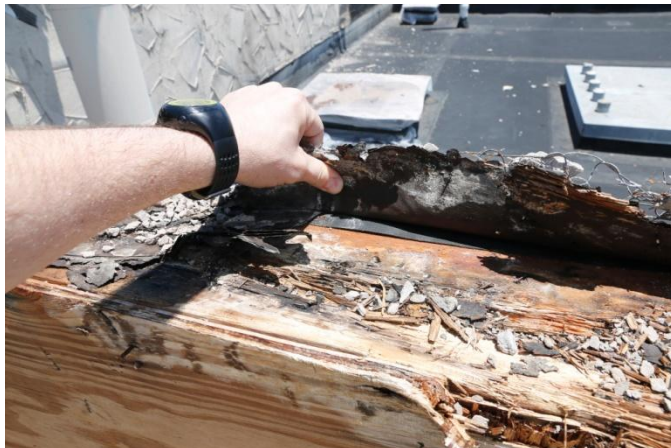
This photo above is particularly interesting. You see that sprinkler head in the foreground? That's the only pipe or penetration I could find anywhere near this massive wall rot area. There was no rot above 4' so the leak wasn't coming from above. Remember that this building is only 10 years old.

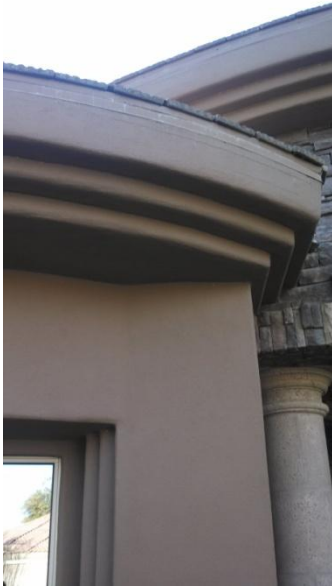
These rotted parapet caps present three lessons. #1 Don't stucco over a Parapet Cap. Stucco is porous and any water that sits on the stucco WILL get through. Parapet caps should have some type of waterproof cap to prevent water from sitting on this horizontal area and leaking behind the WRB (weather resistive barrier). #2 If you MUST do a stucco cap then you'd better **waterproof** behind the stucco. Tar paper is not a waterproofing product. It does resist water, but it's not waterproof. It's paper that's been impregnated with tar. Paper is not waterproof. Tar impregnated paper is also not waterproof.

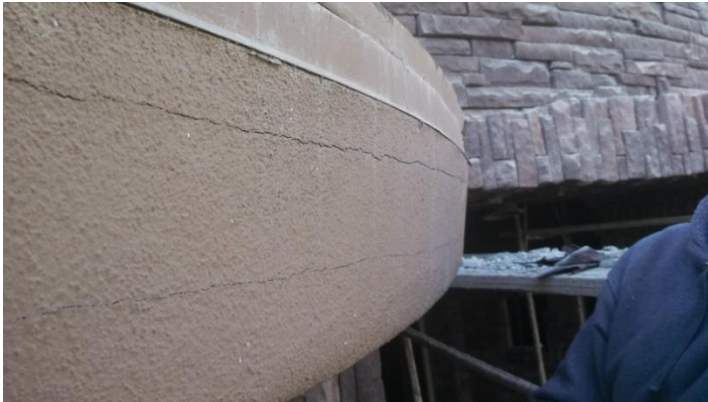
This house in Mesa Arizona is only 9 years old, so what do you think happens when the roof transition to stucco is not properly flashed ?

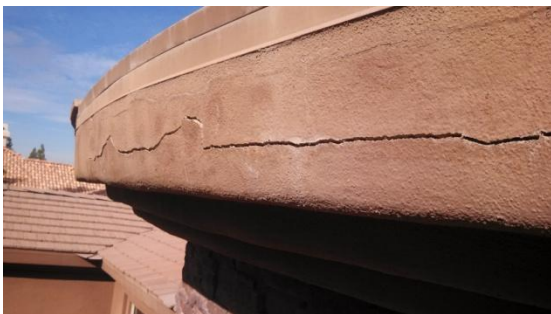
Just cracks, well guess again !

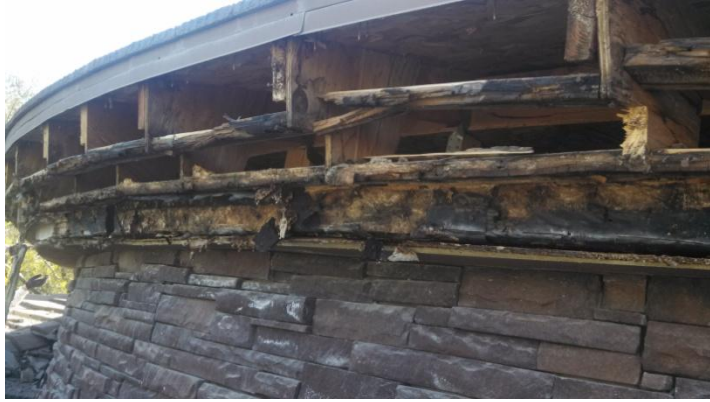
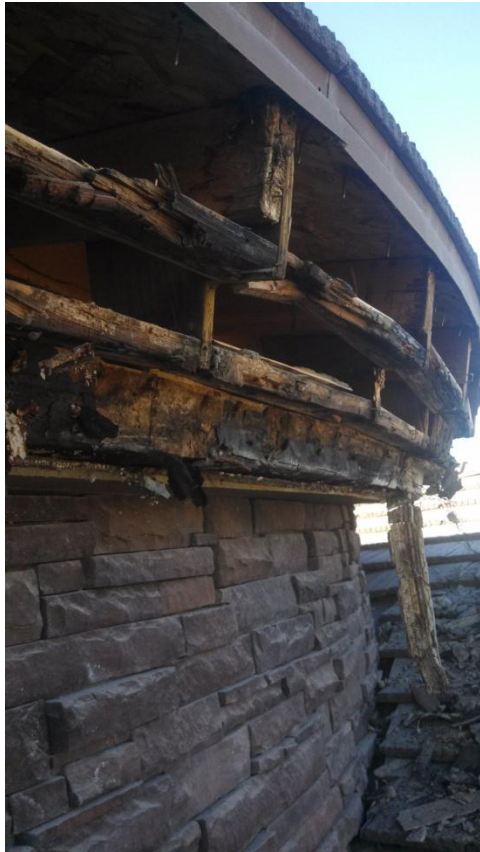
Major Failure, water got behind the vapor barrier and fill up like a bathtub and over the nine years rotted all the lumber, not a good day for the homeowner that had his home Custom Built !

All trades need to work together and communicate, so the job is done right the first time!
